Our File: 2400378 Jacobson Law, USA v. Brown

Re: Expert Witness testimony

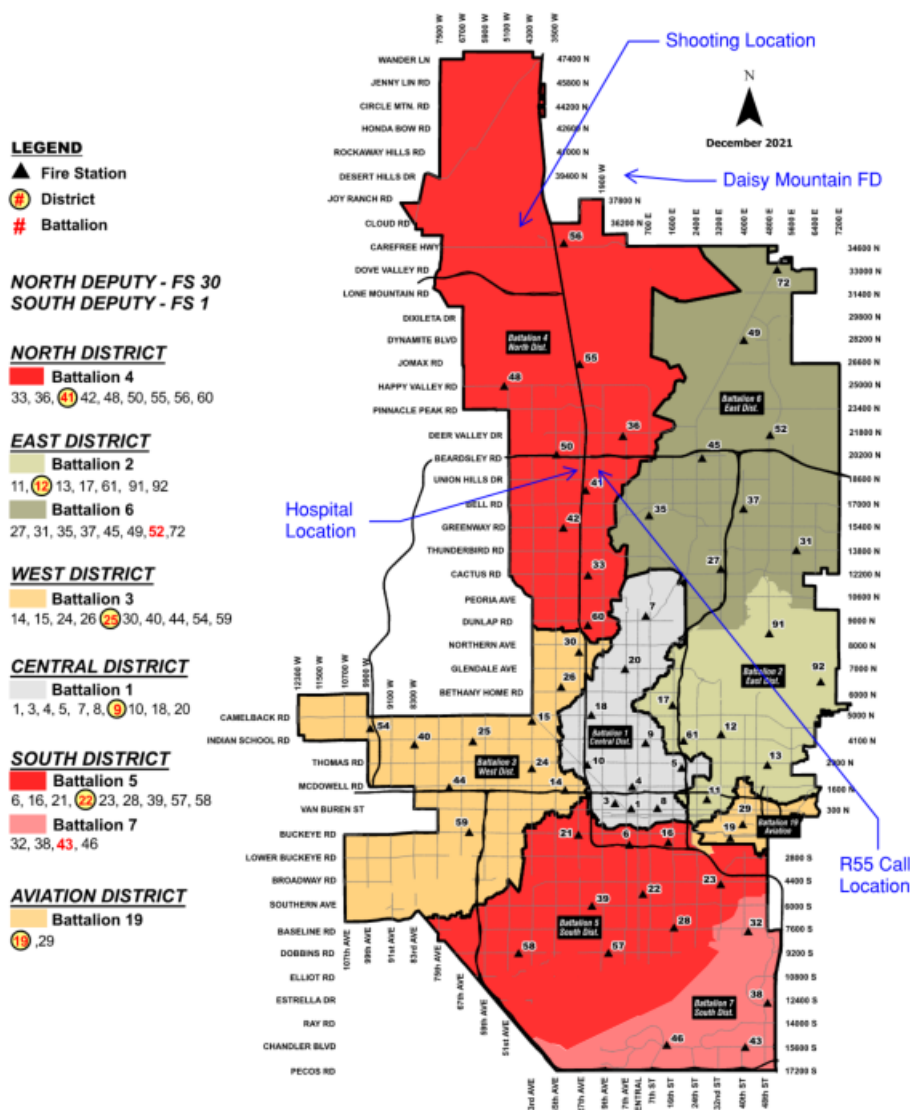
Figure 1 Phoenix FD Station Location Map

At the time of dispatch, Engine 56 was not located at Station 56, which is 2.1 road miles from the incident location³. It is not known where Engine 56 was at the time of the alarm transmission. Phoenix Fire Department dispatch logs show Engine 56 took 8 minutes and 17 second to arrive on scene². Based on the Engine 56 being away from their station district, one Phoenix Fire Department station was located closer to the incident location, Station 55. Station 55 houses two units, Engine 55, and Rescue 55³ (See Figure 1).

GPS pin data obtained from the Phoenix Fire Department through a subpoena shows Rescue 55 to be on another call at the time of this incident, located at 20003 N 23rd Ave #271, Phoenix, AZ 85027⁴ (seen in figure 1). Rescue 55, which is located at the same station as Engine 55, is the only Phoenix Fire Department ambulance located in the northern area of the Phoenix Fire Department’s geographic boundary of coverage³. There is no information as to the location of Engine 55 at the time of this incident. Station 55

is located 6.6 road miles from the shooting location³. Based on Engine 56 being out of their area of coverage, if Engine 55 was located at its station, Phoenix Fire Department Standard Operating Procedure (SOP) would require Engine 55 to respond to the scene as the closest incoming unit. Phoenix Fire Department SOP for EMS Dispatch Procedures requires the closest fire suppression will be dispatched, along with a paramedic unit to specifically defined medical emergencies, including shootings⁵. If dispatch followed departmental required procedures for EMS Dispatch, E56 would not have been dispatched to the scene, but a closer fire unit (Engine 55, if located at its station).

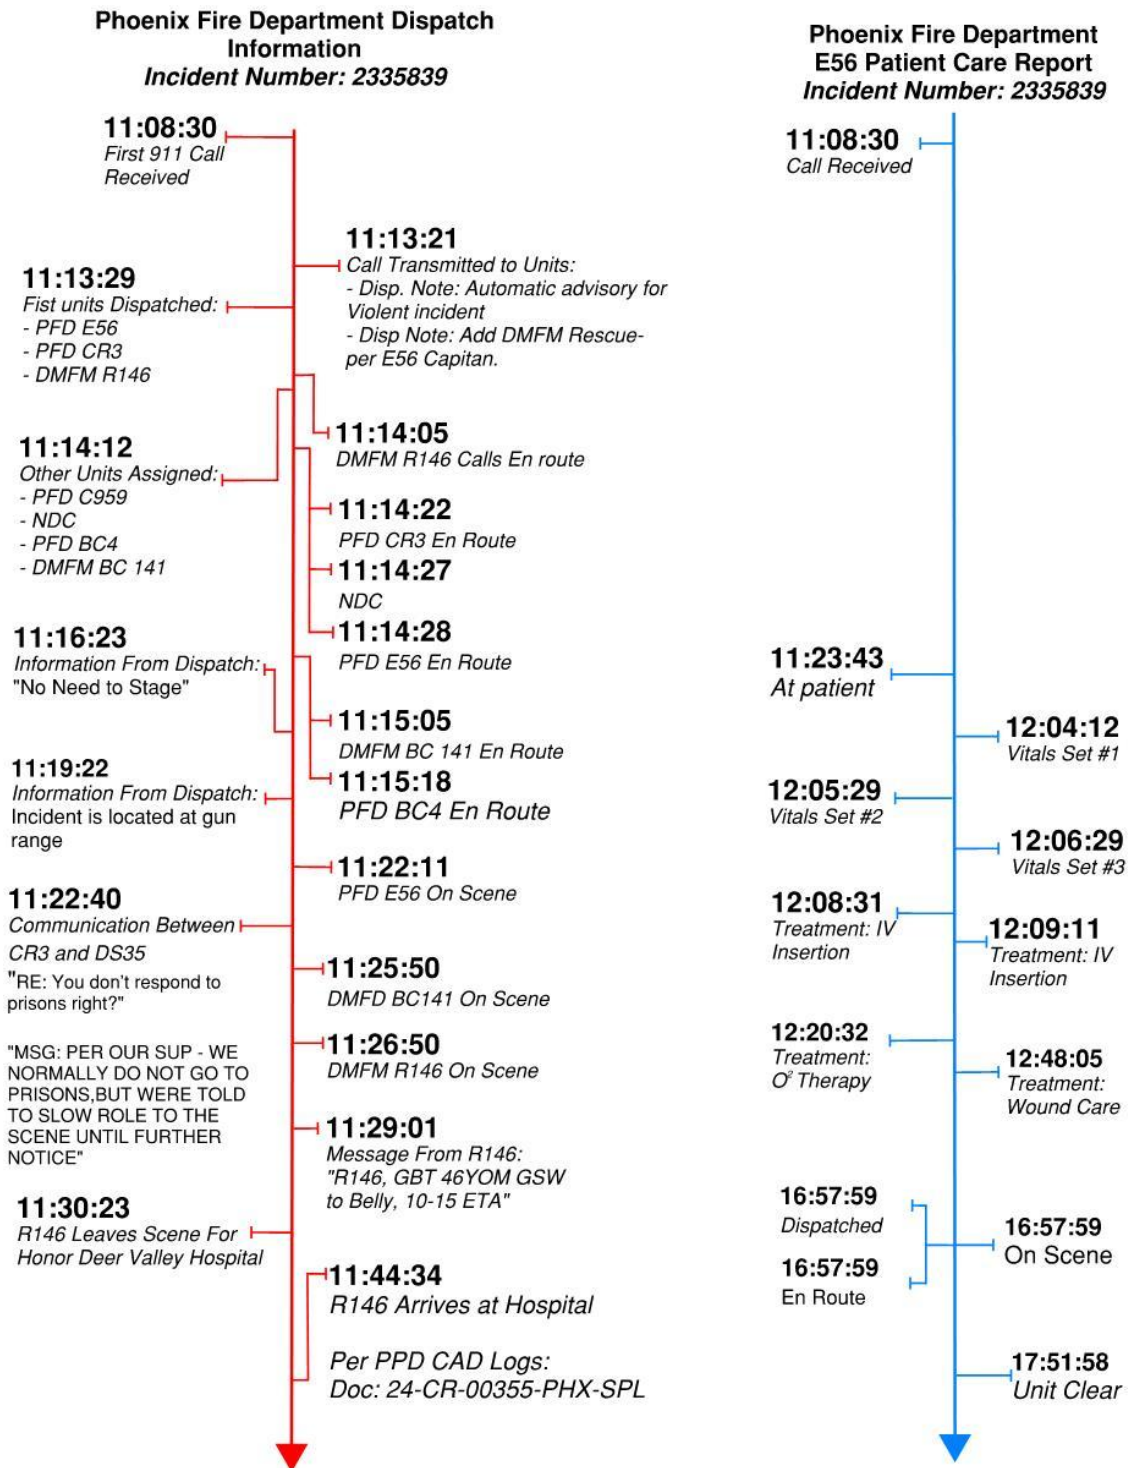
Figure 2: Timeline of Events

The following graphic (Figure 2) displays the comparison between times logged by Phoenix Fire Department dispatch logs, and the PCR from Engine 56 during this incident. The timeline shows significant discrepancies in reporting times published in the PCR, compared to the dispatch logs. Further, the dispatch logs show the extended response times for dispatch, as well as response time for apparatus.

It can also be seen when important information was transmitted to incoming units as to the scene safety, where there was no need to stage, later confusion resulting in units slow rolling into the scene. The location of the incident, stated to be at the gun range, when later confusion had some units believing it was located at the prison.

This timeline shows where critical errors in communication, resource deployment, response, and accuracy in reporting created a response which was not to the industry standards or best practices of the emergency response system.
